PASSAIC RIVER BASIN
RAMSEY BROOK
BERGEN COUNTY
NEW JERSEY

**CRYSTAL SPRING
LAKE
NJ 00231**

**PHASE 1 INSPECTION REPORT
NATIONAL DAM SAFETY PROGRAM**

May, 1979

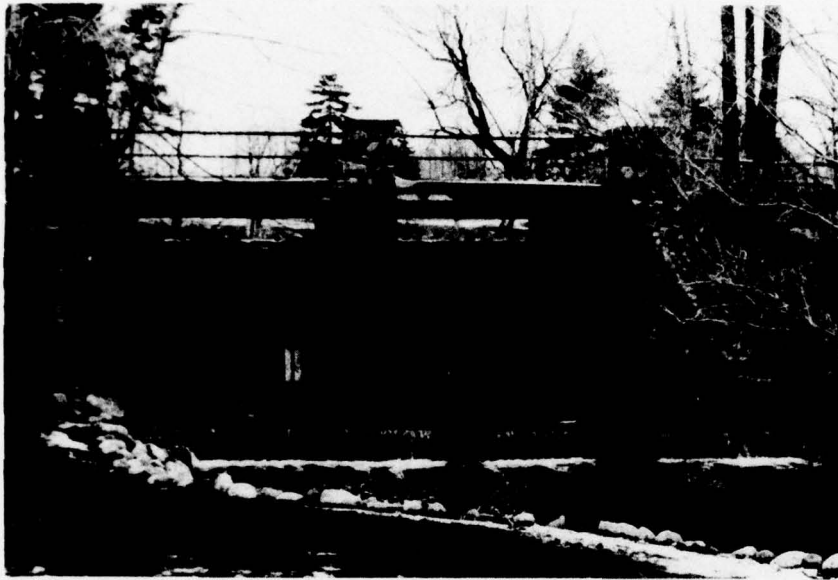
The spillway is a 2-bay overflow weir separated by a bridge deck support pier (Photo 4). Because of its rock masonry construction, discharge over the weir was rather uneven, but the crest and downstream face appeared to be in good condition, with no evidence of erosion or plucking of the masonry (Photo 5). The center bridge pier and masonry training walls have been repaired recently and are in good condition. A new toe wall has been installed at the base of the spillway apron (Photo 4), and the underside of the bridge was recently covered with wire mesh and gunite.

Photo 4 - Downstream View of Spillway.
(November 30, 1978)

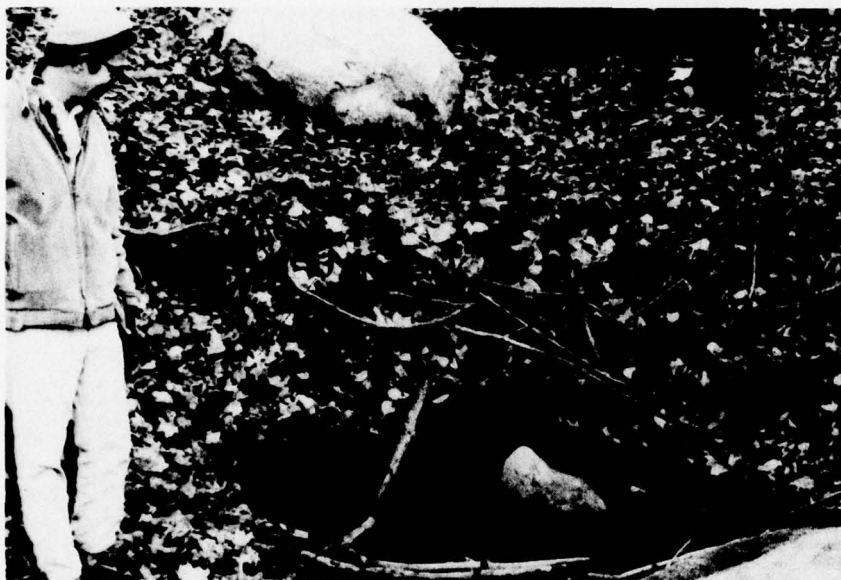
Little of the emergency drain could be observed. It is reported to consist of 2 10-inch pipes controlled by valves in a manhole on the crest of the dam. The manhole was observed to be filled with water to the level of the reservoir and the valves were submerged in 9 feet of water. The downstream outlet was obscured by debris. There was about 1/2 gpm seepage from the outlet area (Photo 6).

Photo 6 - Reservoir drain outlet obstructed by debris. (November 30, 1978)

(3) Repair and clean out the outlet area of the emergency drain and regularly operate the valves to verify that they are in working order.

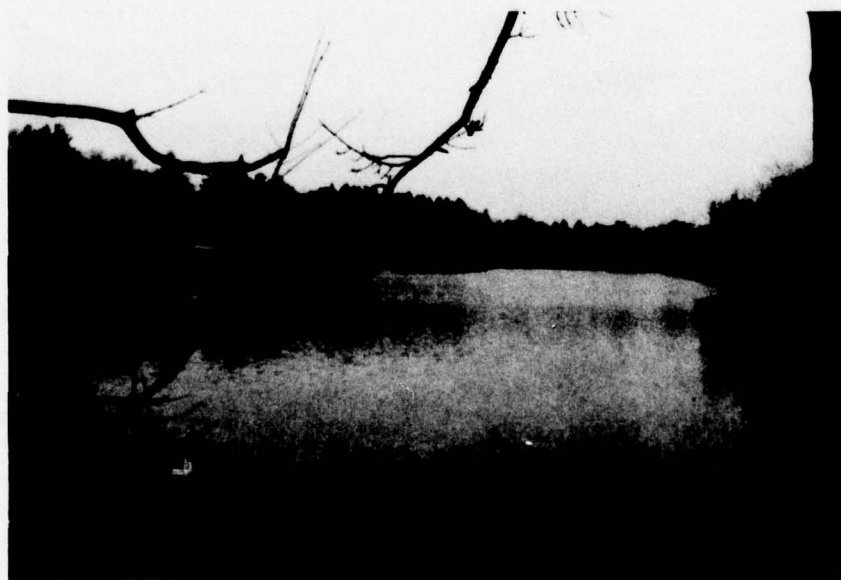
Photo 7 - Reservoir area, looking north. (November 30, 1978)

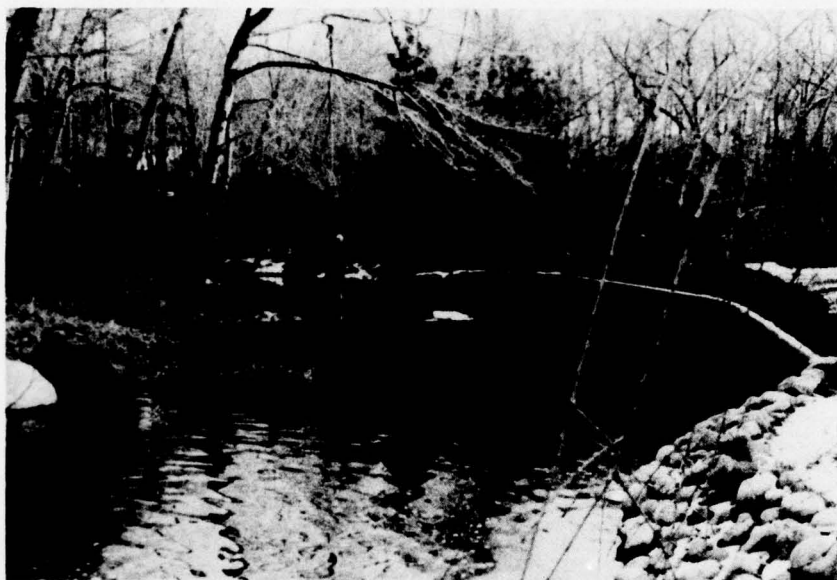
Photo 8 - Concrete weir at end of lined
channel downstream of the spillway.
(November 30, 1978)

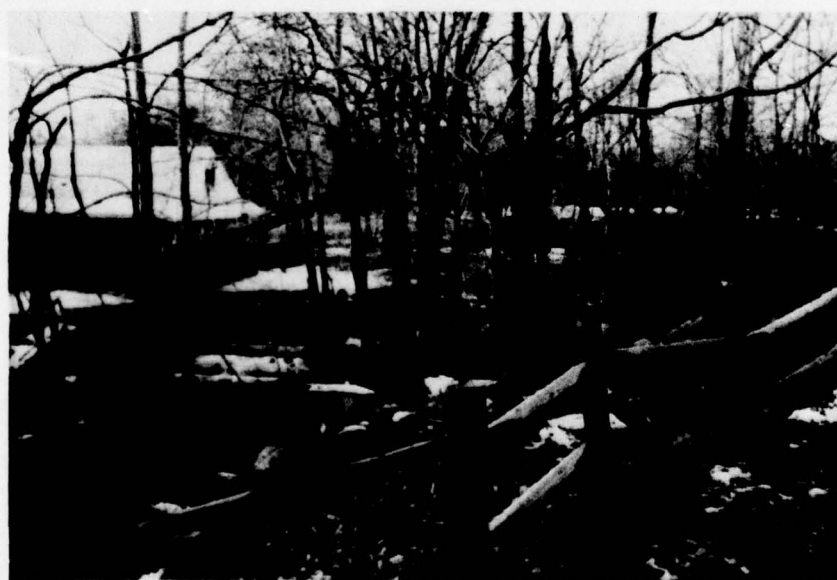
Photo 9 - House on right side of lined
channel downstream of spillway.
(November 30, 1978)
